Tucherbräu at the opera house

Nuremberg's traditional pub in new splendour.

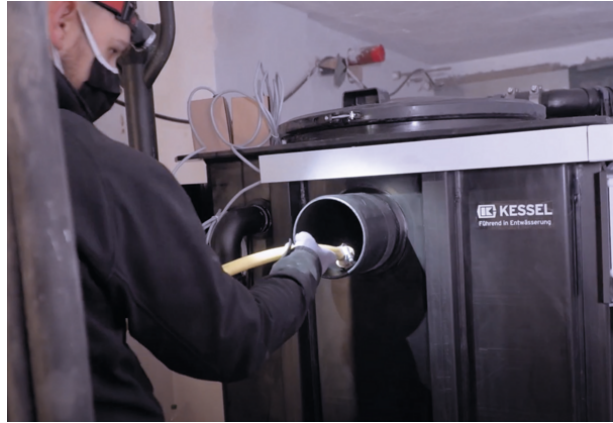
On-site welding of the grease separator with subsequent quality and leak test. (Source: SHK TV)

The "Tucherbräu am Opernhaus" in Nuremberg, which has been vacant since 2012, will be completely renovated by 2022. The original listed building was destroyed down to its foundation walls during the Second World War. It was rebuilt between 1946 and 1949 and is currently being modernised during the refurbishment. Since all technical requirements had to be adapted to the given premises on site, it was decided that the grease separator would be welded and assembled in its final location.
